Docket No. 217 – Development and Management Plan Inspection

Northeast Utilities Service Company Certificate of Environmental Compatibility and Public Need for the construction of a 345-kV electric transmission line and reconstruction of an existing 115-kV electric transmission line between Connecticut Light and Power Company's Plumtree Substation in Bethel, through the towns of Redding, Weston, and Wilton, and to the Norwalk Substation in Norwalk, Connecticut.

Norwalk Substation

Date: May 4, 2006

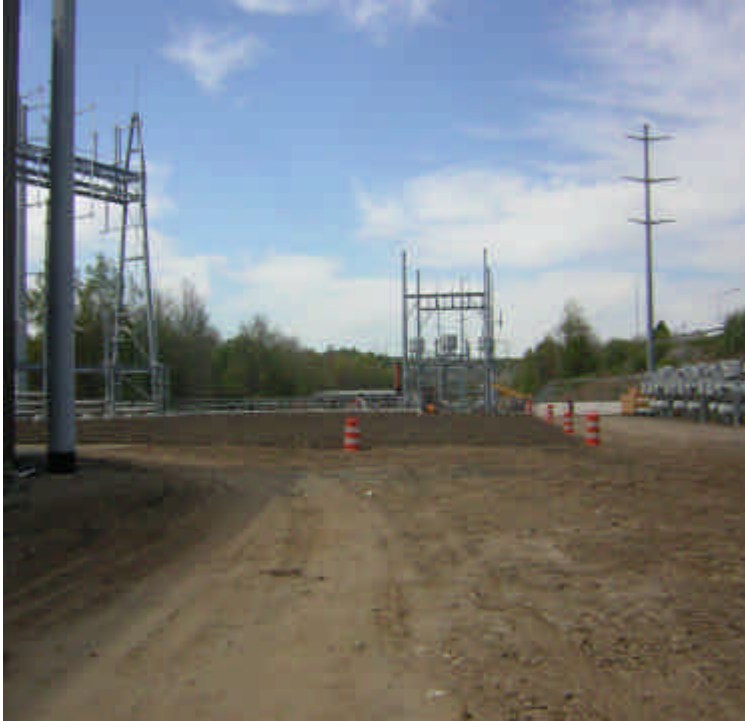
Norwalk Substation: Photo on the left shows where topsoil was spread adjacent to the GIS building. Photo on the right shows an overview of the yard. Some materials for other portions of the project are stored here. 5/4/06.

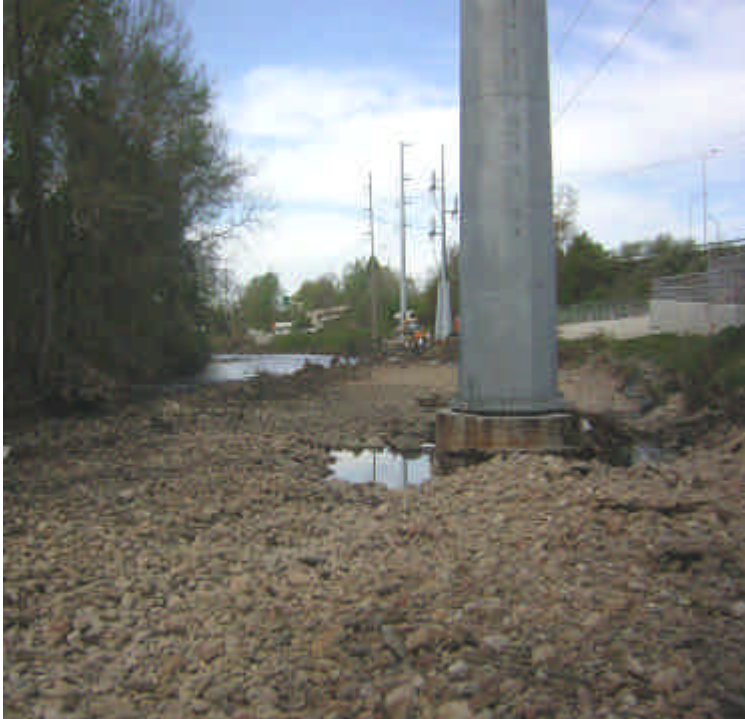
Inland Wetland and Watercourse encroachment and mitigation	- The overflow channel and natural overflow area were still flowing but the water level had receded further. 5/4/06. - The minor erosion noted along the top of slope at	-Repairs will be made to the slope near the turning structure. 5/4/06 - None at this time. 5/4/06.	-N/A -N/A.

Photo on the left shows the area of the turning structure. Erosion here from the flooding will be restored. Photo on the right shows a view of the overflow channel. Flooding did not cause erosion here. 5/4/06.

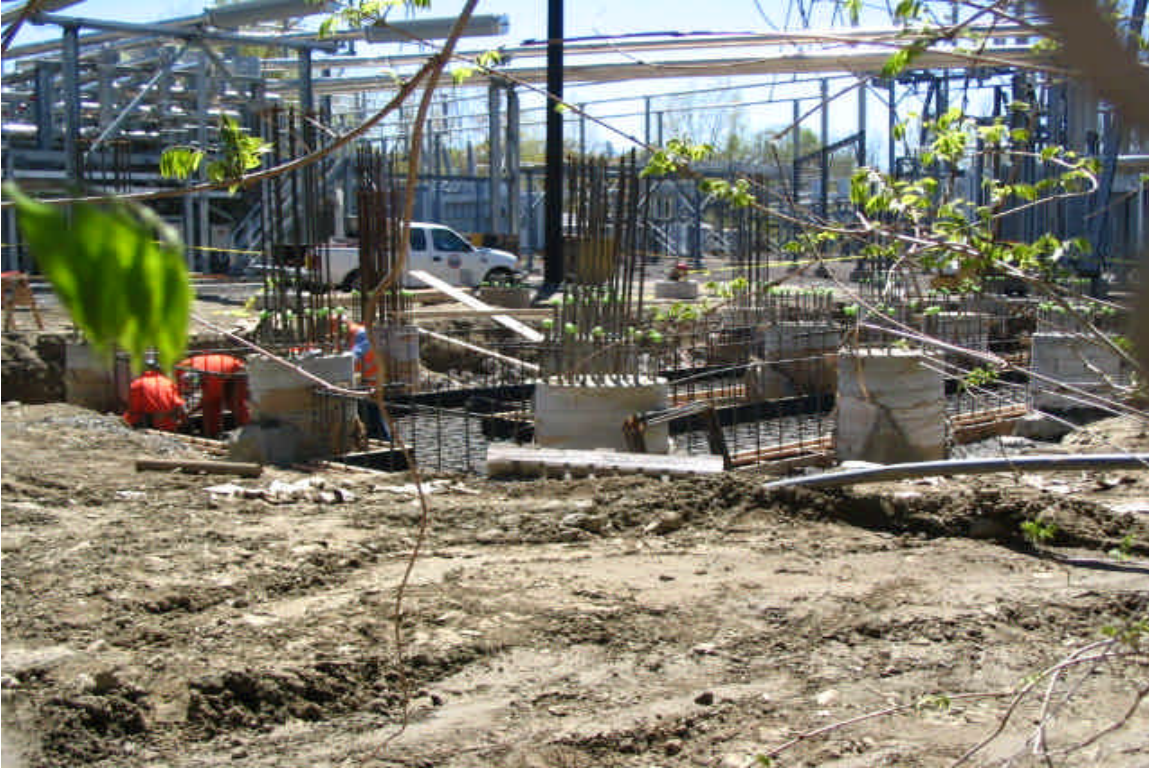
Plumtree Substation: Photo shows a view of foundation construction occurring within the station yard. 5/4/06.

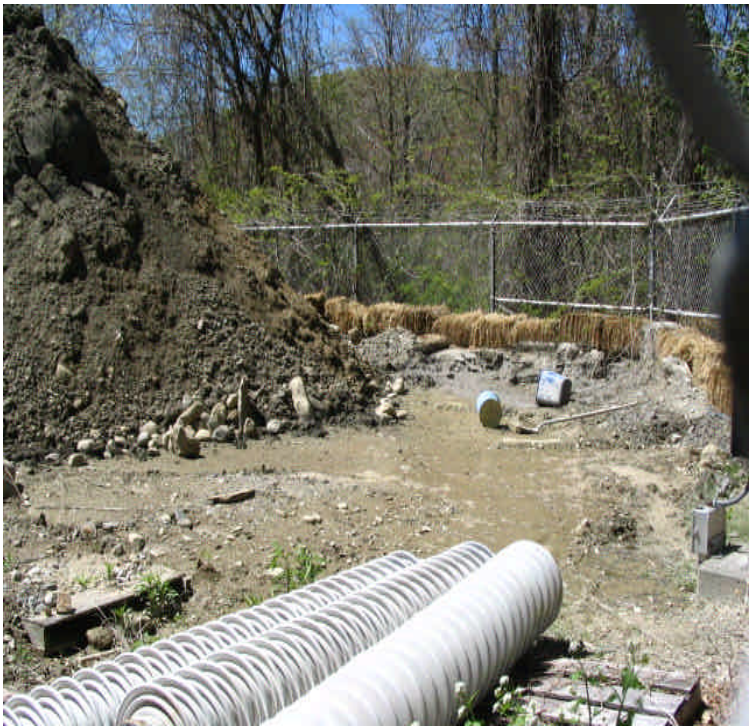
Photo on the left shows the rear of the site with haybales remaining along the perimeter. A stockpile is close to the fence here and could be pulled back if feasible. Photo on the right shows an overview of the yard and some of the stockpiles. 5/4/06
